JWI LOUVRES – CLIENT ADVICE

Job Number: 13038

Project: ASPIRE APARTMENTS

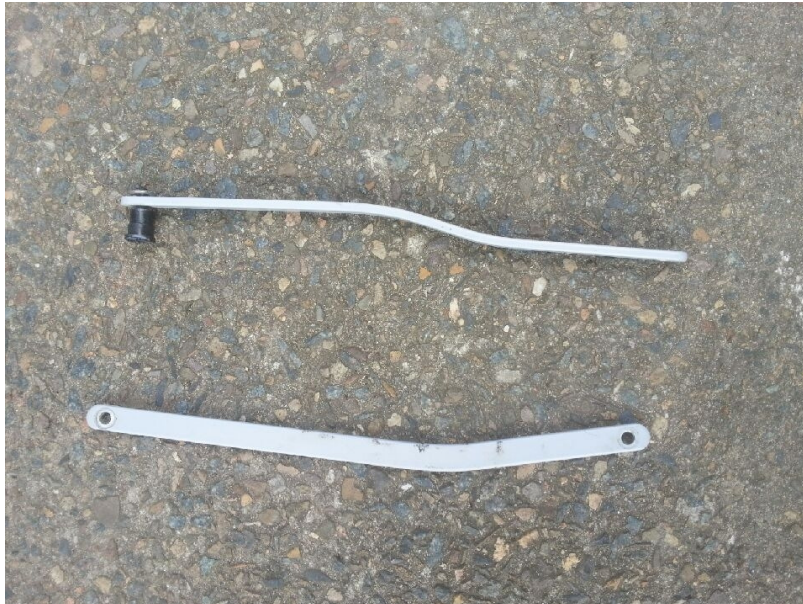
There has been a lot of damage done to the louvres from over tightening of the louvre system.

The louvres are **not a full blackout system and cannot be forced closed**. When the blades shut they are not to be cranked any further closed. Even if there are light gaps between some of the blades they are not to be cranked so much that they bend the aluminium components. Please see attached photos of damaged components.

To **OPEN** the louvres you turn the gearbox in an **ANTI-CLOCKWISE** direction.

To **CLOSE** the louvres you turn the gearbox in an **CLOCKWISE** direction.
